RIBuild
Robust Internal Thermal Insulation of Historic Buildings

Intro till EU-projektet RIBuild
Praktisk vägledning till applicering av invändig tilläggsisolering i kulturhistoriska byggnader

Lukas Lång, RISE

Fuktcentrums informationsdag,
Lund, 2019-11-28

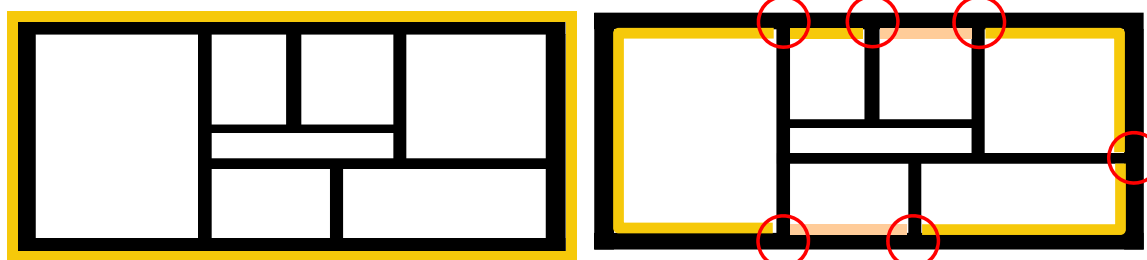
Originalvägg

Invändig isolering

1. Befintlig vägg blir kallare
2. Svårt att undvika köldbryggor
3. Reducerad uttorkning

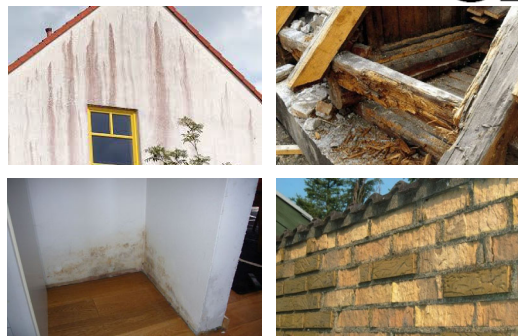
- Skademekanismer som hanteras:
 - Mikrobiell påväxt
 - Röta
 - Frost
 - Alger och missfärgning
- Modeller för skador
- Gränsvärden för skador
- Materialtester

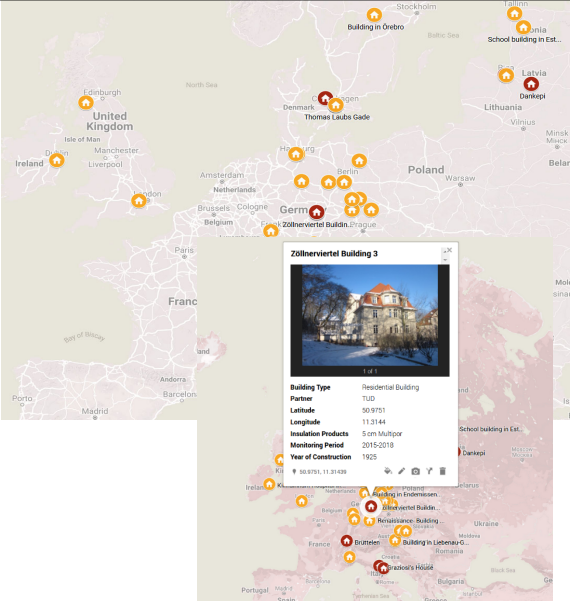
Zöllnervertel Building 3

Building Type	Residential Building
Partner	TUD
Latitude	50.9701
Longitude	11.3144
Insulation Products	5 cm Multipor
Monitoring Period	2015-2018
Year of Construction	1925

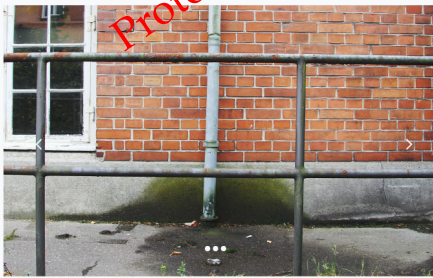
Where to look for risks

1. Surfaces with water streams often moistened for long periods
2. Porous or rough building materials such as bricks, stones and mortar
3. North-facing walls not directly irradiated by the sun
4. Balconies, roof overhangs and roof drain
5. Damaged waste-water pipes

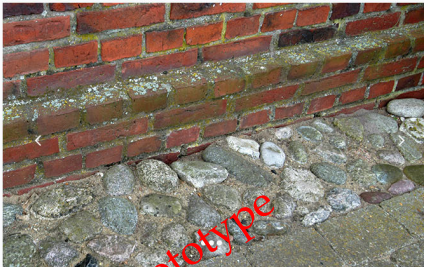
Where to look for risks

1. Surfaces with water streams often moistened for long periods
2. Porous or rough building materials such as bricks, stones and mortar
3. North-facing walls not directly irradiated by the sun
4. Balconies, roof overhangs and roof drain
5. Damaged waste-water pipes

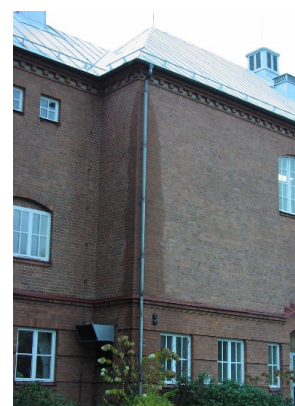
Establish defect rain water collection system		Cause	Possible mitigation:
Inspection after heavy rain fall:	Wet spots around water collection system (horizontal and vertical pipes)	Leakages in the piping system	Locate and fix the leakage /blockage
Inspection in frost:	Icicles from eaves, chutes and pipes	Can be congested pipes	Clean the piping system
General inspection	Regular assessment of entire building facade – especially joints	Water can stand still and accumulate on horisontal surfaces, e.g. around friezes	Locally damaged joints close to water collection system should be filled in
